Manhole Inspection Summary

Manhole # S47C__033MH

Insp Date: 7/11/08 11:04 AM

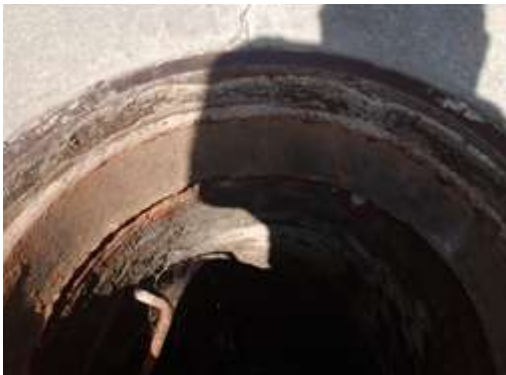
Defect 2

☒ **Leaks**

frame leaks

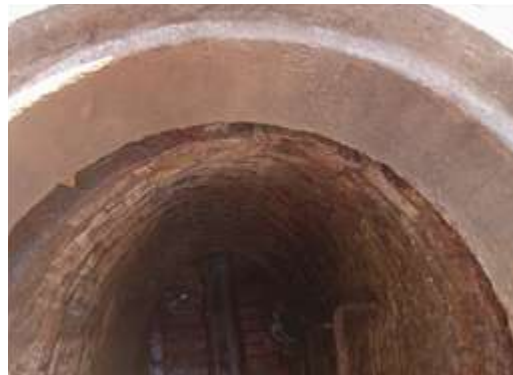
Defect 1

Condition: ☐ Sound ☐ Cracked ☐ Root Intrusion ☒ **Loose Brick** ☐ Deteriorated

Infiltration: ☐ None ☐ Joint ☐ Cracks ☒ **Mortar** ☐ Roots ☐ Wall

infiltration

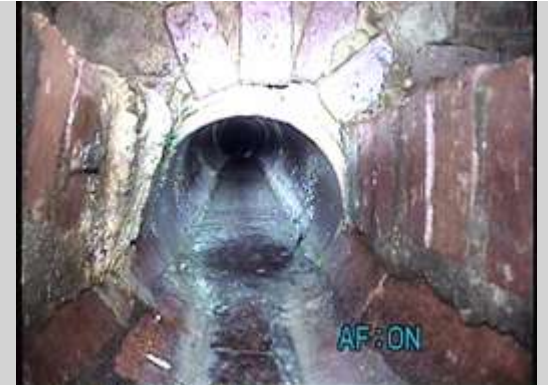
12 O'Clock Outflow

8 in. Circular Gravity Sewer
Pipe Out @ 12 O'Clock

Pipe Height: **8.4** (in.) Rod and Bar (Angled)
Pipe Material: **Clay** ☐ Pipe Lined
Invert Depth: **10.50** (ft.) Flow Characteristics: **Fast**
Deposits: ☒ None ☐ Mud ☐ Sludge ☐ Debris ☐ Grease
Silt Depth: (in.) Deposits Extent:
Infiltration: **None** Pipe Seal Cond: **Sound**

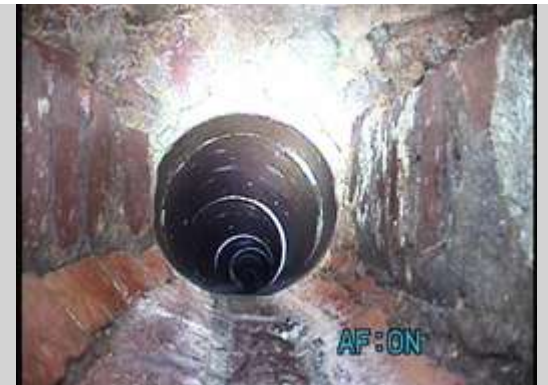
6 O'Clock Inflow

8 in. Circular Gravity Sewer
Pipe In @ 6 O'Clock

Pipe Height: **8.4** (in.) Rod and Bar (Angled)
Pipe Material: **Clay** ☐ Pipe Lined
Invert Depth: **10.00** (ft.) Flow Characteristics: **Fast**
Deposits: ☒ None ☐ Mud ☐ Sludge ☐ Debris ☐ Grease
Silt Depth: (in.) Deposits Extent:
Infiltration: **None** Pipe Seal Cond: **Sound**
